The Investigation of Negative Effects of Salt Dome on the Quality of Water in the Gotvand Olya Dam and the use of Cut-off Wall as Treatment

Key words: Gachsaran Salt Dome, Gotvand Olya River, Clay wall, Water Quality

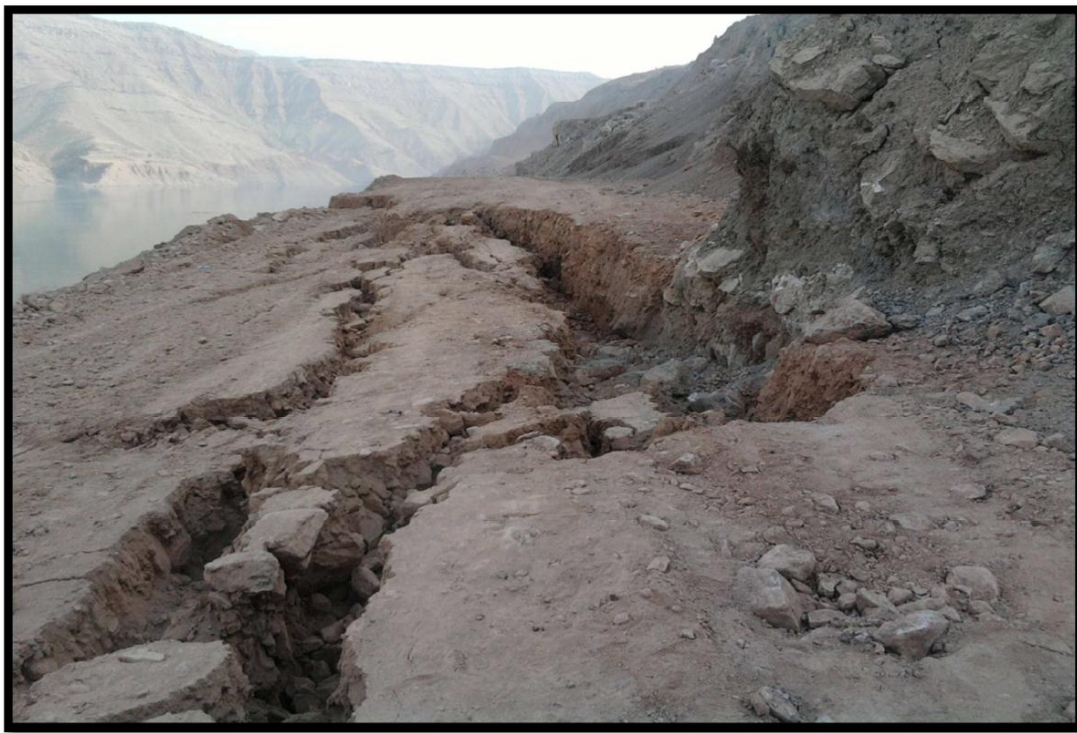
- Cancelling the transition later implementation: due to sinking of the only mine of these materials SB
- Change in the implementation method of materials: after impounding, for stability and filling of the hole, clay and riprap materials were evacuated in form of damp on the band and the contraction of material was done by the traffic of road construction machineries (figure3).

Fig 3: cracking in the embankment after dam impounding

Based on the technical specification and the instruction provided by project consultant and contractor, first the clay should be used in clay wall in form of 30 cm layers. After preparation procedures including spraying, mixing, regulating and pummelling by the proper rollers, the final thickness of each layer should reach 25 cm, then after executing density test and determining soil density (at least 92%), the next layer will be implemented. However, due to contractor's hurry for dam impounding in the shortest possible time, the embanking process was executed unsystematically. The first step before impounding is embankment, which has been done in 70-90 cm layers, and then preparation and pummelling have been done. The second step is after impounding, which due to not preserving technical principles in the first step, immediately after impounding, the built wall subsided. For removing this problem, according

to the report provided by the contractor, the embankment operation was done by soil deposit and the contraction was done by traffic of road-construction machineries.
